## Workshop on “Wheel Slide Protection” System of LHB Coaches

As per the decision taken in the 14<sup>th</sup> CMG, a workshop on WSP maintenance was conducted on 27/06/16 and 28/16/16 at IRIMEE for officers and supervisors. There were sixty seven participants representing RDSO and 14 zonal railways and consisted of 15 posted officers (six nominated exclusively for this workshop and 9 group B officers attending 10 week induction course at IRIMEE), 20 IRSME Probationers and 32 posted Supervisors.

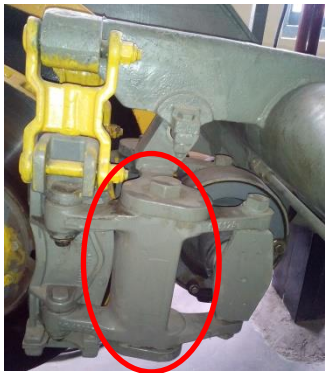
S. No.	Item of discussion	Action to be taken	Responsibility
1.	<p>Some of the depots reported that they have observed that the movement of the brake caliper arm is not free. They have reported that that the brake caliper center pin does not rotate freely when turned by hand. Depot staff remove these pins, clean and grease them as well as the bushes and re-fit them. This is a cumbersome process requiring about 1 hour per brake caliper.</p>

<p>This aspect needs to be examined by other maintenance depots. RDSO may also study the issue and advise further course of action.</p>	<p>CRSEs of all zonal railways and ED/Carriage RDSO</p>
